What is a CAP?

CAP locations, 2002

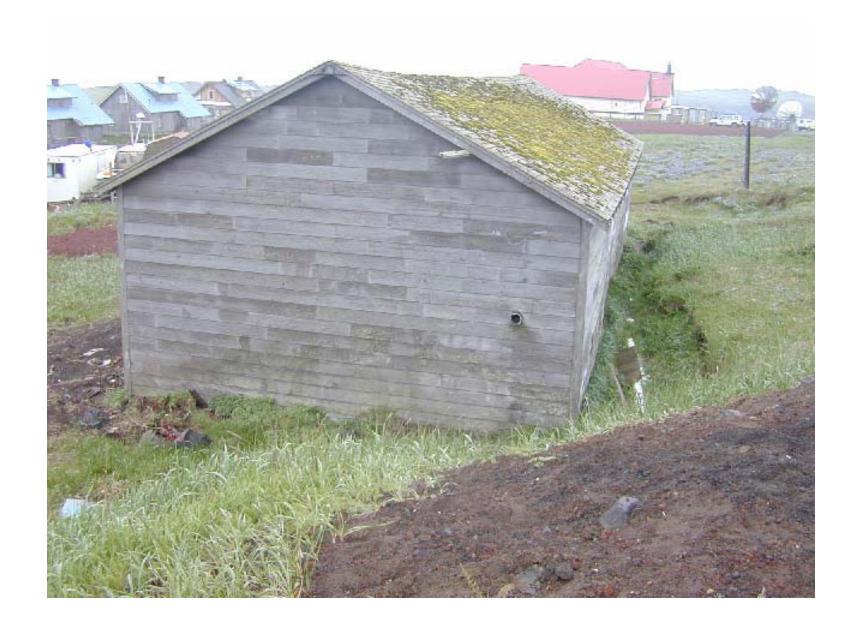
OMT: The site

- Diesel contamination from tank used for heating the building
- Small, simple site, chosen to build expertise and confidence
- Less than 30 CY PCS removed and treated
- Sampling indicates that site is clean
- Former Power Plant (Duna's Kitchen)
 - Contamination from fuel tanks and pipes used for power generation
 - Nearly 400 CY removed and treated
 - Additional work due to underground vault containing heavy oil
 - Restoration included a rock wall to support the road
 - Sampling results pending

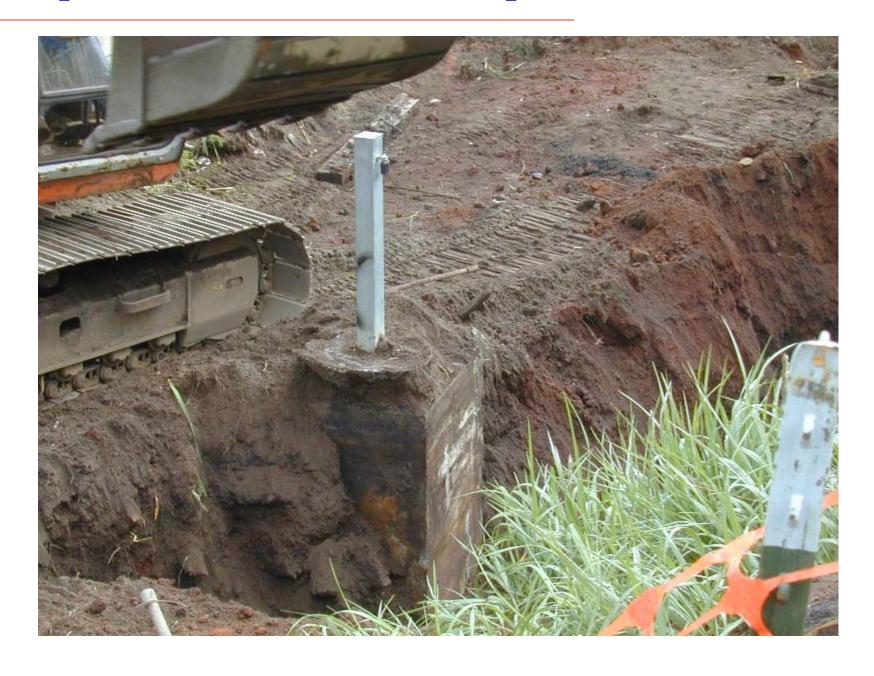
Surprise! The well in the sump

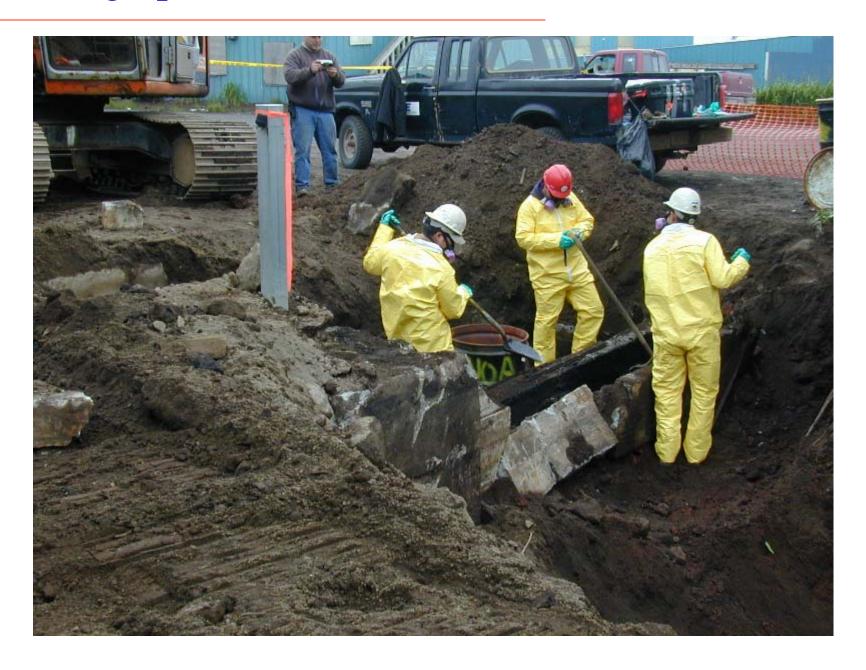
Cleaning up the oil

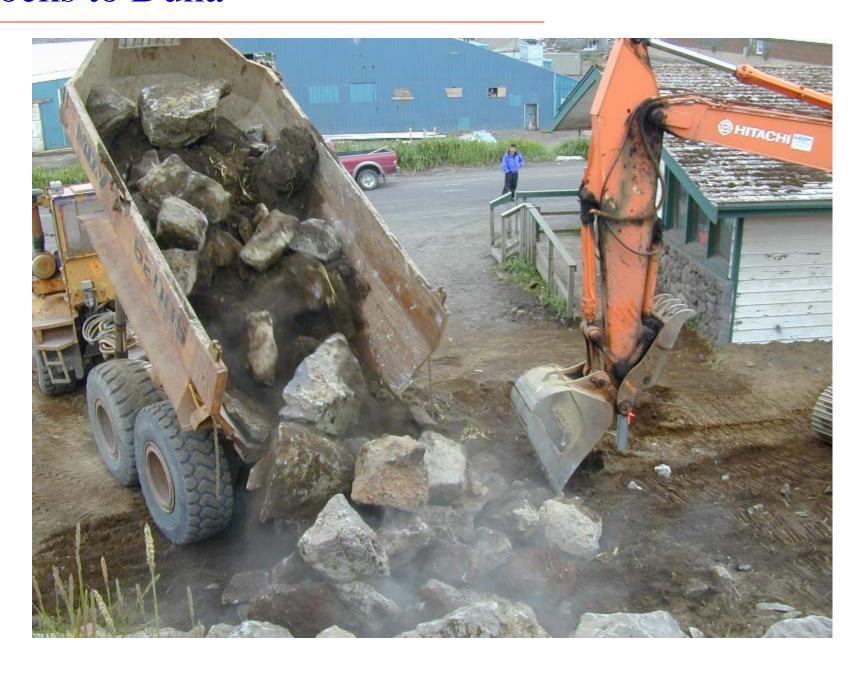
Rocks to Duna

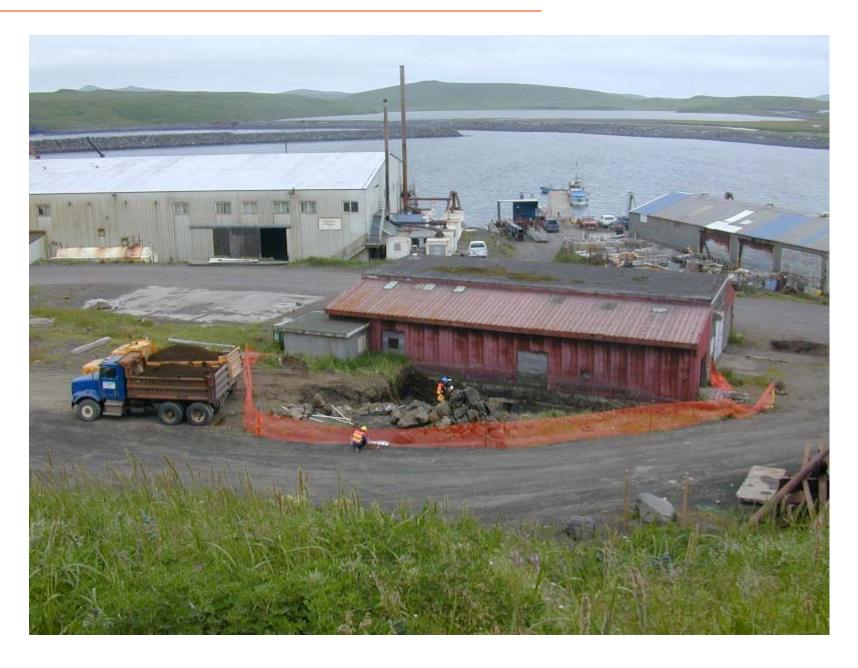
DPP: The site

- Decommissioned Power Plant
 - Contamination mostly from fuel tank used for power generation
 - Nearly 250 CY removed and treated
 - Fuel tank under building instead of perpendicular to it
 - Site restored to grade
 - Sampling results pending

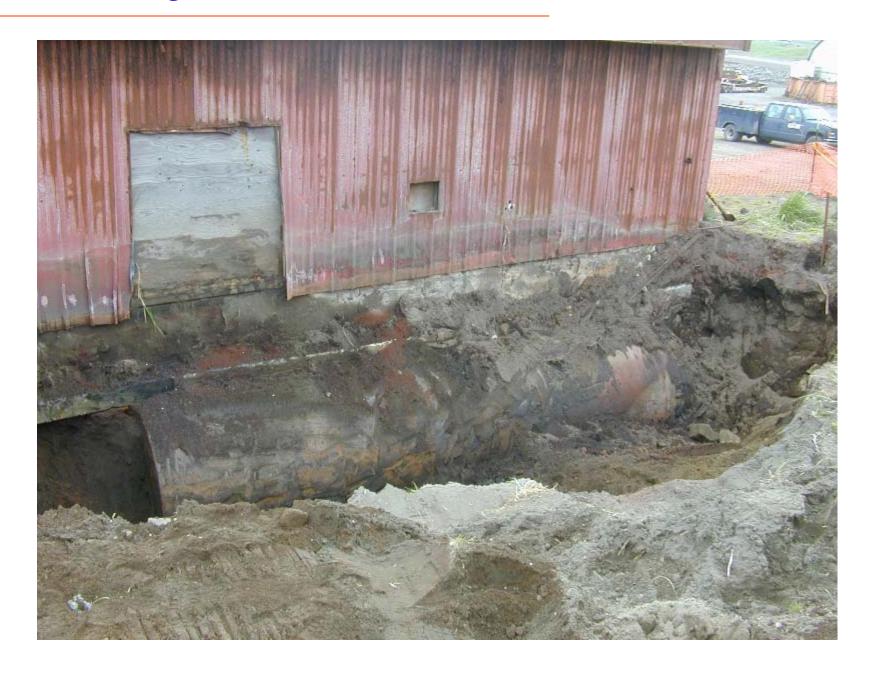
The building on the tank
